**DEPARTMENT OF TRANSPORTATION**

Contract #: 04-0120F4Cty: SF/ALA Rte: 80 PM: 13.2/13.9File #: 69.28**WELDING INSPECTION REPORT****Resident Engineer:** Pursell, Gary**Address:** 333 Burma Road**City:** Oakland, CA 94607**Report No:** WIR-003942**Date Inspected:** 29-Aug-2008**Project Name:** SAS Superstructure**OSM Arrival Time:** 630**Prime Contractor:** American Bridge/Fluor Enterprises, a JV**OSM Departure Time:** 1530**Contractor:** Zhenhua Port Machinery Company, Ltd (ZPMC), Changxing Island **Location:** Shanghai, China**CWI Name:** AB/F Wang Heng**CWI Present:** Yes No**Inspected CWI report:** Yes No N/A**Rod Oven in Use:** Yes No N/A**Electrode to specification:** Yes No N/A**Weld Procedures Followed:** Yes No N/A**Qualified Welders:** Yes No N/A**Verified Joint Fit-up:** Yes No N/A**Approved Drawings:** Yes No N/A**Approved WPS:** Yes No N/A**Delayed / Cancelled:** Yes No N/A**Bridge No:** 34-0006**Component:** OBG Assembly**Summary of Items Observed:**

**OBG Assembly Bay II**

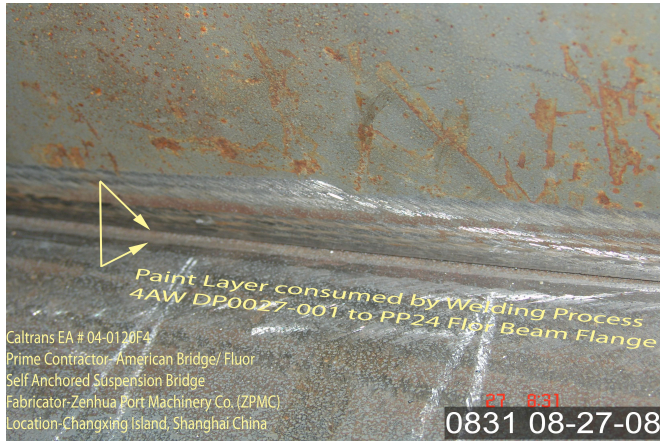
5AE- QA observed tack welding by the SMAW process at floor beam FB13A to bottom plate BP110 and BP56A. QA also observed that the welder was about to weld over paint and QA queried AB/F QC personnel Wang Heng as to what he was going to do about this potential incident. Mr. Heng mentioned that he would have the paint and detritus removed in the joint prepped areas and that the three previous tack welds produced over paint would be removed. QA observed prior to leaving the location that the above mentioned grinding of said tacks welds was commencing.

QA was approached by ZPMC representative Mr. Testino and he produced a copy of D1.5 (2002) and mentioned that ZPMC considered the paint to be a light rusty prohibitive coating. QA mentioned that this was a situation to be elevated to his superiors and that his argument could not be resolved at this QA inspectors level. However, QA did mention that the paint associated with this process was .....paint and will produce hydrogen which will in turn potentially damage and reduce the quality of any weldment and indeed cause cracking induced by the hydrogen.
